GULF COUNTY RESTORE ACT PROJECT PRE-PROPOSAL FORM

Project Name: St Joseph's Bay Seagrass enhancement and meadow creation

Submitting Entity: Seagrass Recovery, Inc.

Summary Report for St. Joseph Bay

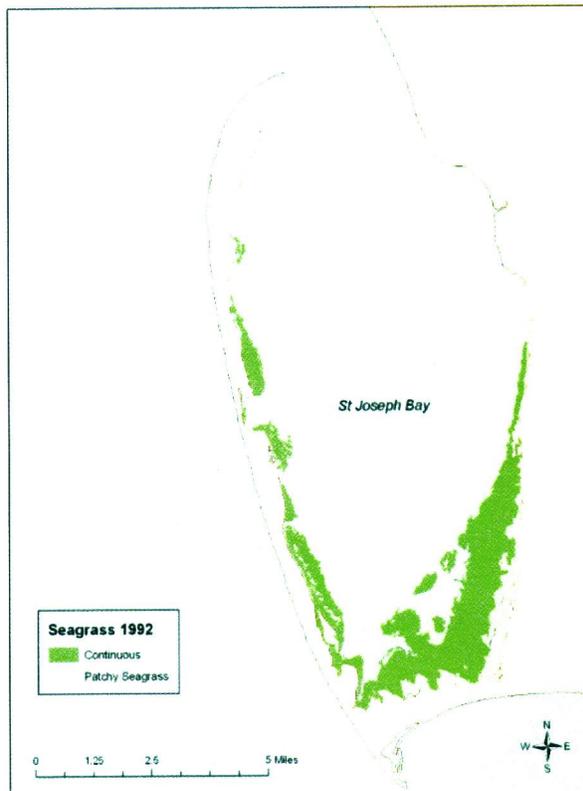
Figure 1. Seagrass cover in St. Joseph Bay, 1992.

Geographic Extent: St. Joseph Bay is located in the central Florida Panhandle in Gulf County (Figure 1). The bay is bounded on the eastern shoreline by the city of Port St. Joe and St. Joseph Bay State Buffer Preserve lands and on the west by the St. Joseph Peninsula and St. Joseph Peninsula State Park. The total surface area of the bay at mean high water is approximately 43,872 acres (Hemming et al. 2002).

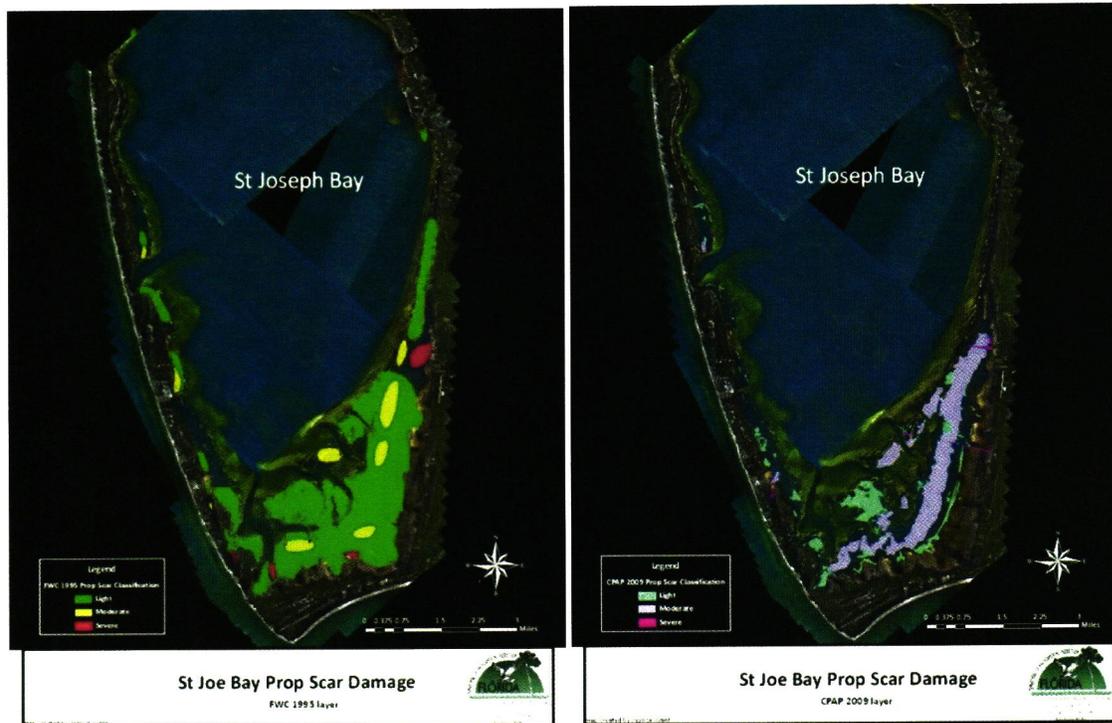
Figure 2. Hyperspectral imagery interpreted to show propeller scarring in 1992 and 2006.

Summary Assessment: Seagrass cover and species composition in St. Joseph Bay are stable; however, propeller scarring has increased in the southern portion of the bay (Figure 2). Monthly nutrient monitoring at seven sites in the bay has also indicated increased nitrogen in the bay which may be the cause of increased algal growth and epiphyte coverage on seagrass blades.

Seagrass Mapping Assessment: Seagrass acreage in St. Joseph Bay appears to have decreased between 1992 and 2006, from 9,740 acres to 6,672 acres (Table 1); however, the acreage estimates are based on data collected using two methods. In 1992 and 1993, cover estimates were made using aerial photography; in 2006, hyperspectral imagery was interpreted to estimate seagrass cover. Hyperspectral imagery collected in 2010 will provide another assessment of trends. In 1992–93, about half of all seagrass beds (4,840 acres) exhibited propeller scarring (Figure 2). By 2006, scarred areas had been reduced to 1,900 acres, but moderately scarred areas had increased by 900 acres.

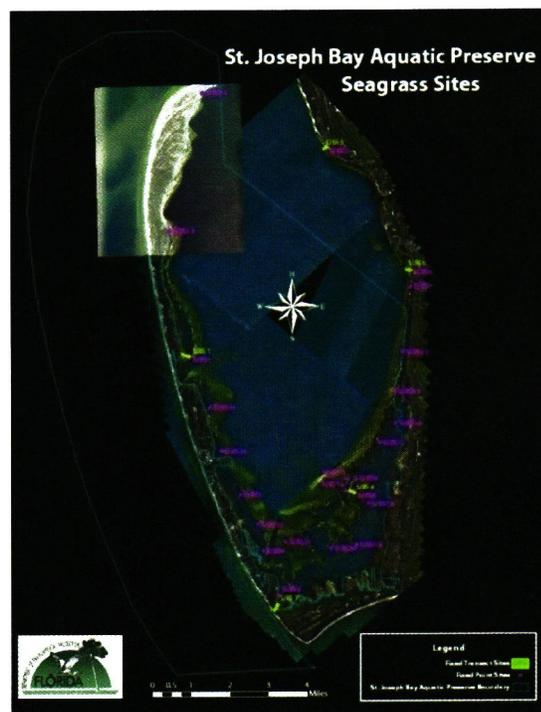
Figure 3. Seagrass monitoring sites in St. Joseph Bay.

Monitoring Assessment: St. Joseph Bay seagrass beds were monitored by Florida Department of Environmental Protection (FDEP) CAMA staff twice a year from 2002 through 2008 at fixed locations (Figure 3). Since 2009, seagrass monitoring has been conducted annually. In recent years, seagrass beds appear stable in size and species composition. Turtle grass (*Thalassia testudinum*) is the dominant species found in the bay and occurs at depths to 9 ft. Manatee grass (*Syringodium filiforme*) occurs frequently with turtle grass and is predominantly located in areas along the eastern shoreline of the bay. Epiphyte loads on seagrass blades are increasing, presumably due to increasing nutrients in the water column, and propeller scarring continues to affect seagrass beds.

Monitoring Data: Seagrasses have been monitored in St. Joseph Bay each year since 2002 by FDEP CAMA staff. Seagrass and macroalgal cover are estimated by species for four quadrats at 25 fixed sites throughout the bay (Figure 3). Other data collected include canopy height, epiphyte coverage and type, sediment type, other organisms present, biomass samples (taken occasionally), epiphyte samples for laboratory analysis, underwater photographs or video, and depth. Water quality parameters include dissolved oxygen, temperature, salinity, pH, turbidity, Secchi depth, and light attenuation.

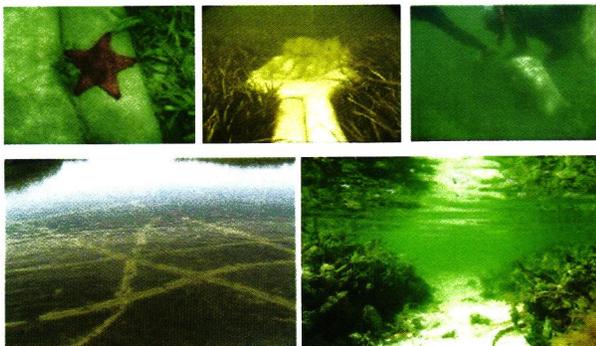
Sediment Tube technology

- Proprietary technology with over 8 years of scientific study and improvements
- Fabric blend that contains proprietary nutrients that are specially designed to restore injury sites within 18-24 months with scientifically validated results
- Used to stabilize and recovery seagrass injury sites including:
 - Boat Groundings
 - Propeller Scars
 - Pipeline Scars

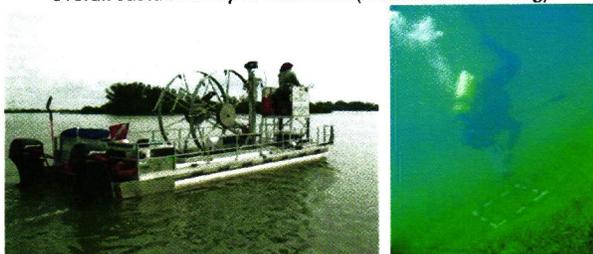
Large Scale Seagrass Meadow Creation and Enhancement

- Automated Planting wheel utilizing the Nutri-Gator vessel for seagrass planting unit deployment which drastically speeds up the planting process
- Proprietary nutrient enhancements using the injection wheel attachment that enables increased expansion and overall sustainability of meadows (created and existing)

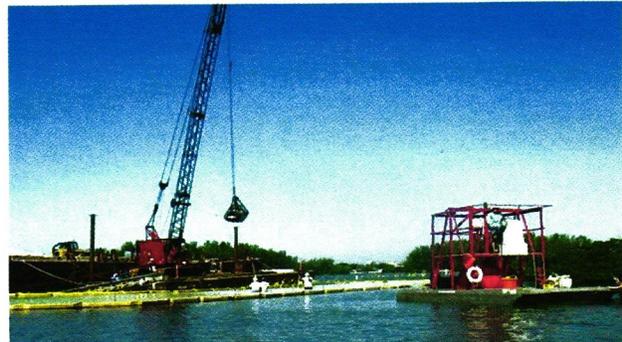
Mechanized Large Scale Transplantation Services (GIGA Technology)

- Award winning proprietary technology with over 6 years of scientific study and improvements
- Transplants 20 ft2 sections of seagrass, including the substrate and support system which drastically improves success rates
- Encourages fast expansion of large planting units allowing for large meadow creation with very little donor material
- Scientifically validated in peer reviewed literature citing expansion rates of 40x—165x the planted material
- Scientifically validated success in utilizing salvage material for the purpose of new meadow creation
